Debris/Ice/TPS Assessment and Integrated Photographic Analysis of Shuttle Mission STS-65

*Gregory N. Katnik, Barry C. Bowen, J. Bradley Davis,
Vehicle Engineering/Mechanical System Division/ET Section,
Kennedy Space Center, Florida*

July 8, 1994

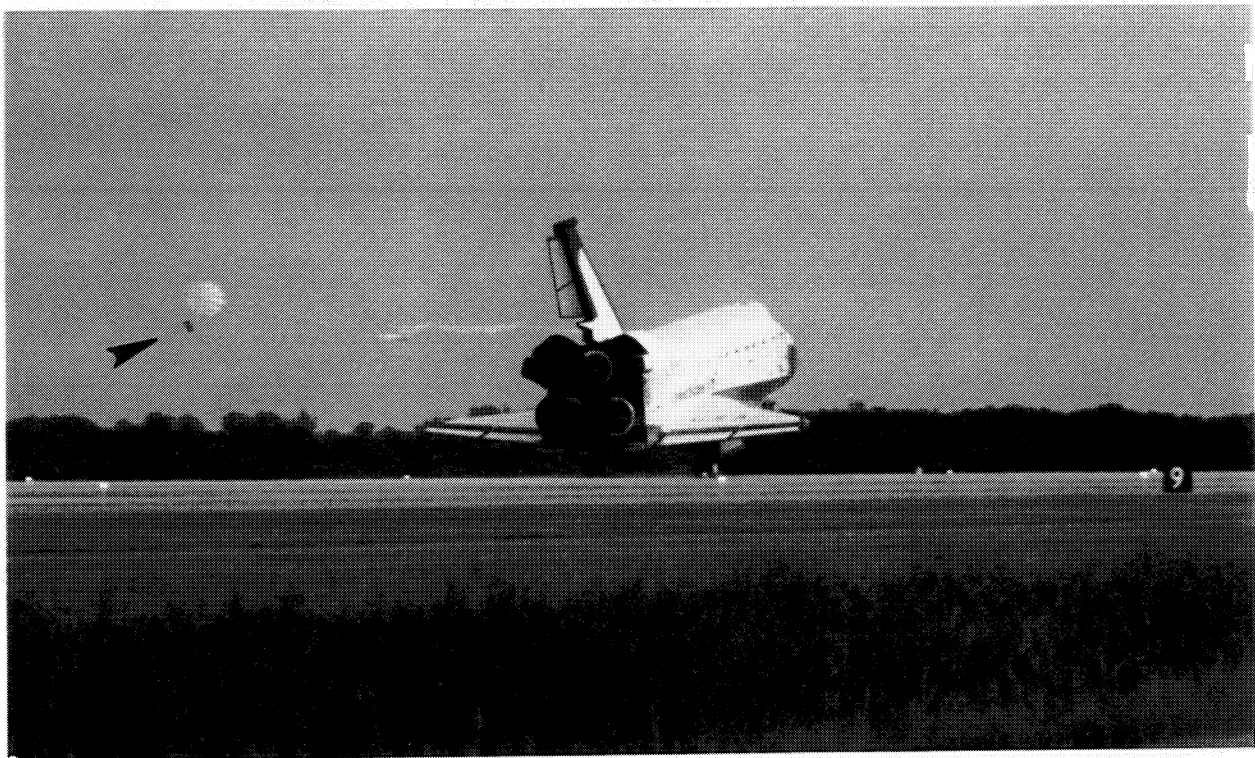
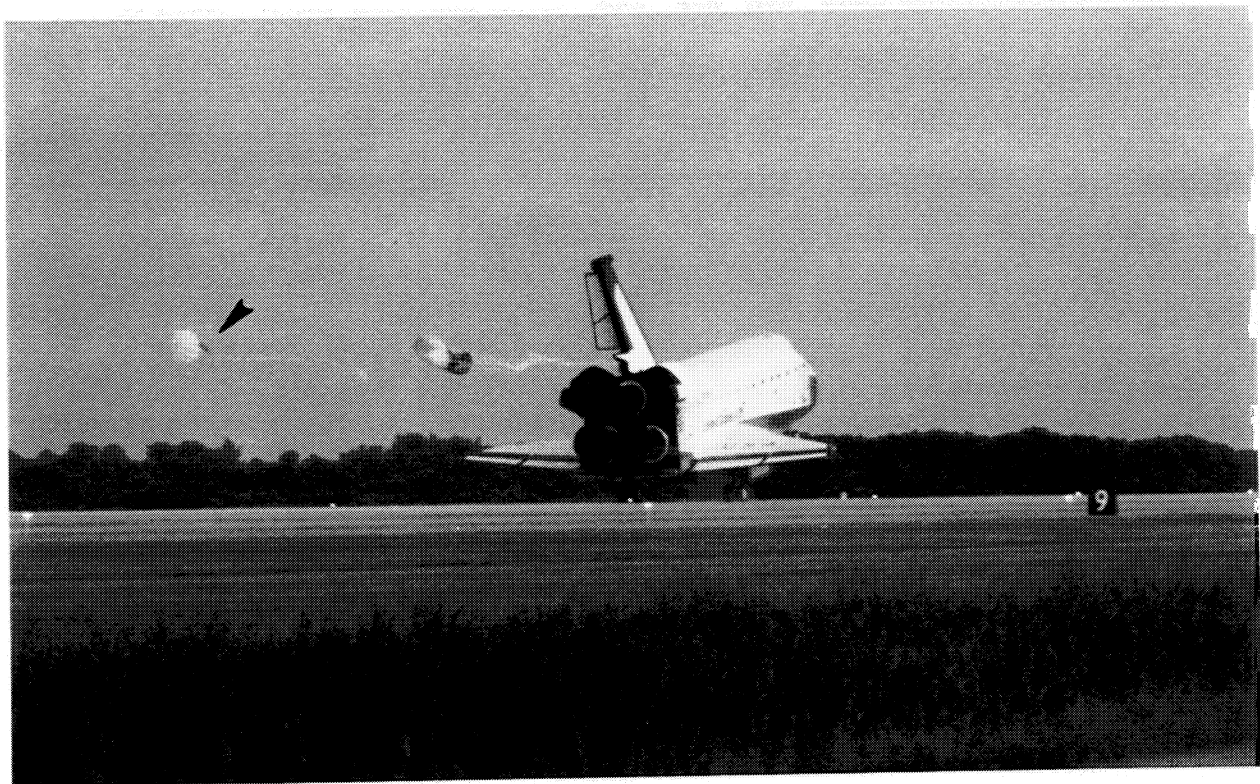
Photo 17 : Drag chute door contact with pilot chute during landing.

Pilot chute deployment appeared nominal though the chute risers were contacted by the drag chute door caught in aerodynamic vortices aft of the Orbiter. Function of the pilot chute was not affected and movement of the drag chute door did not threaten drag chute deployment, which appeared nominal.

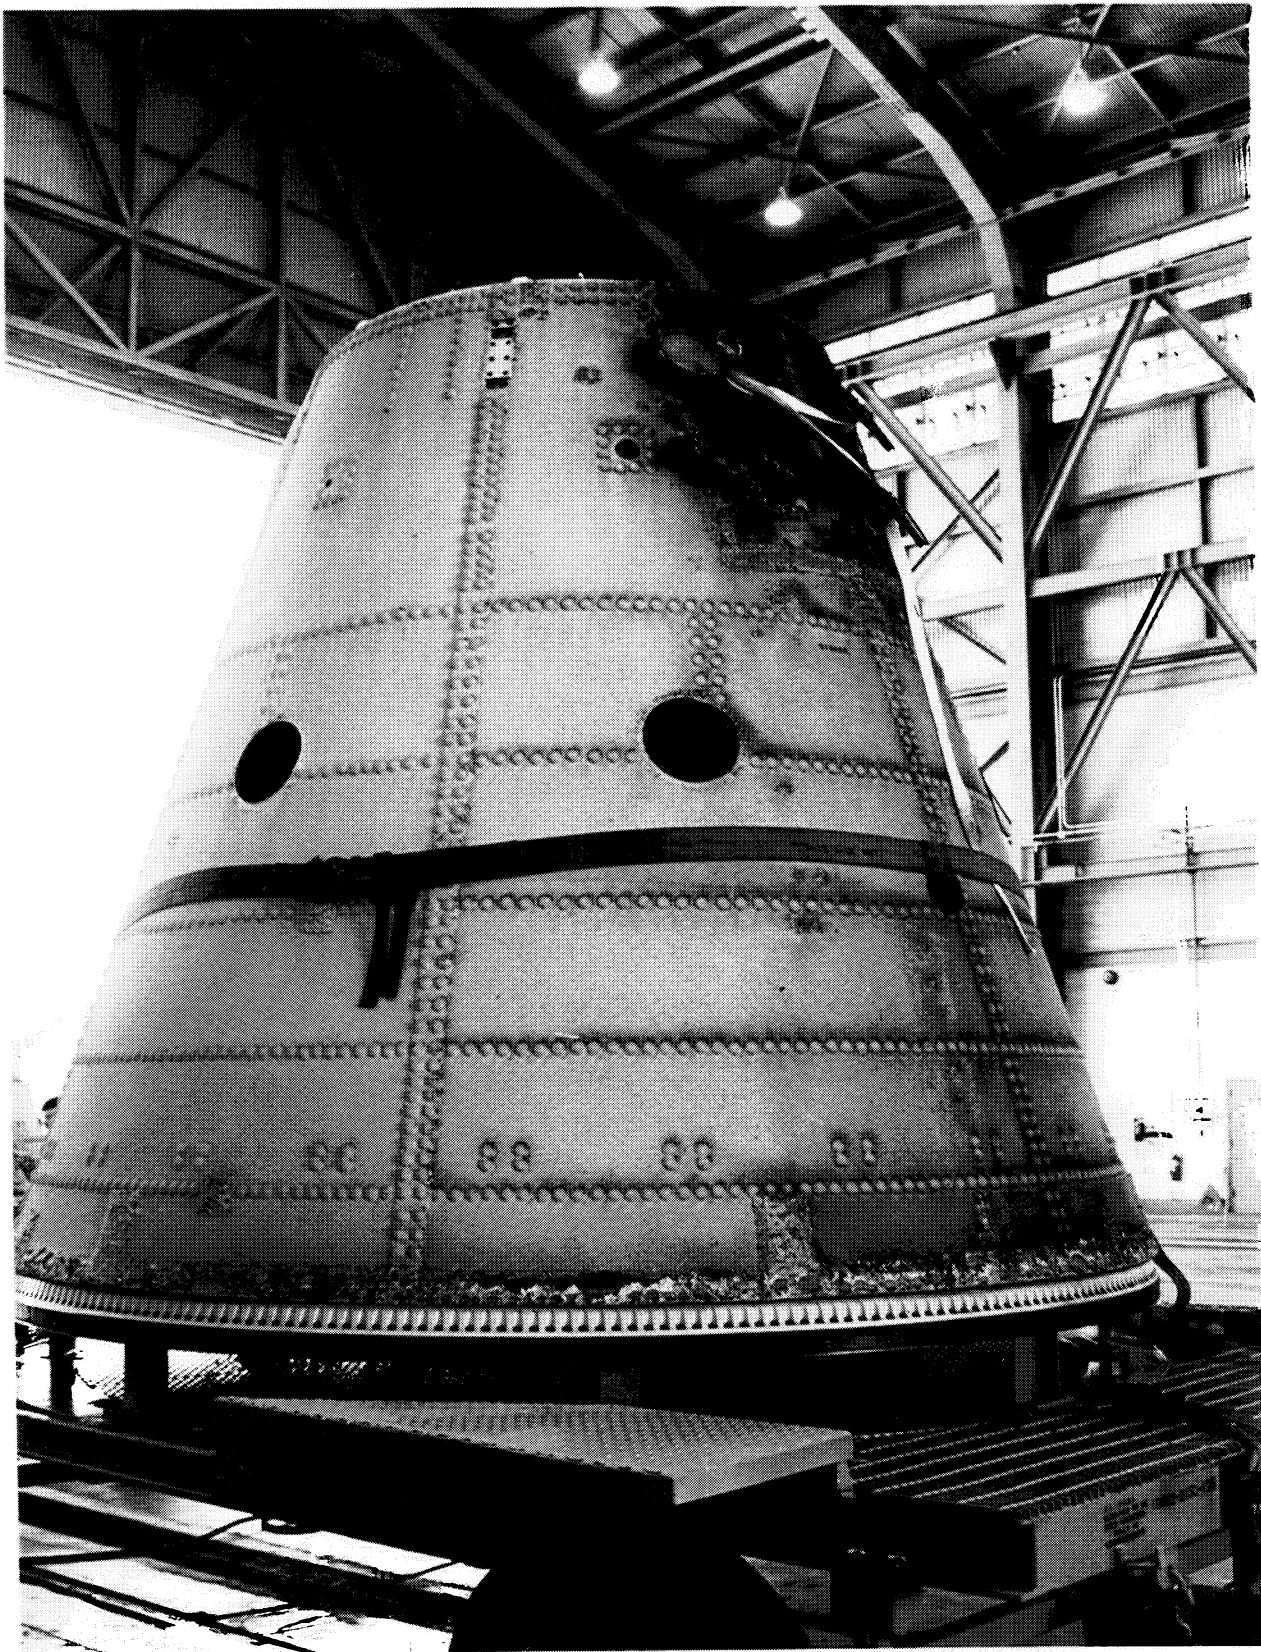
Photo 18 : RH SRB Frustum

The RH frustum had 24 MSA-2 debonds over fasteners. One of the two 2"x1" areas of missing TPS is visible between the 275 and 318 ring frames (arrow). The BSM aero heat shield covers had locked in the fully opened position.

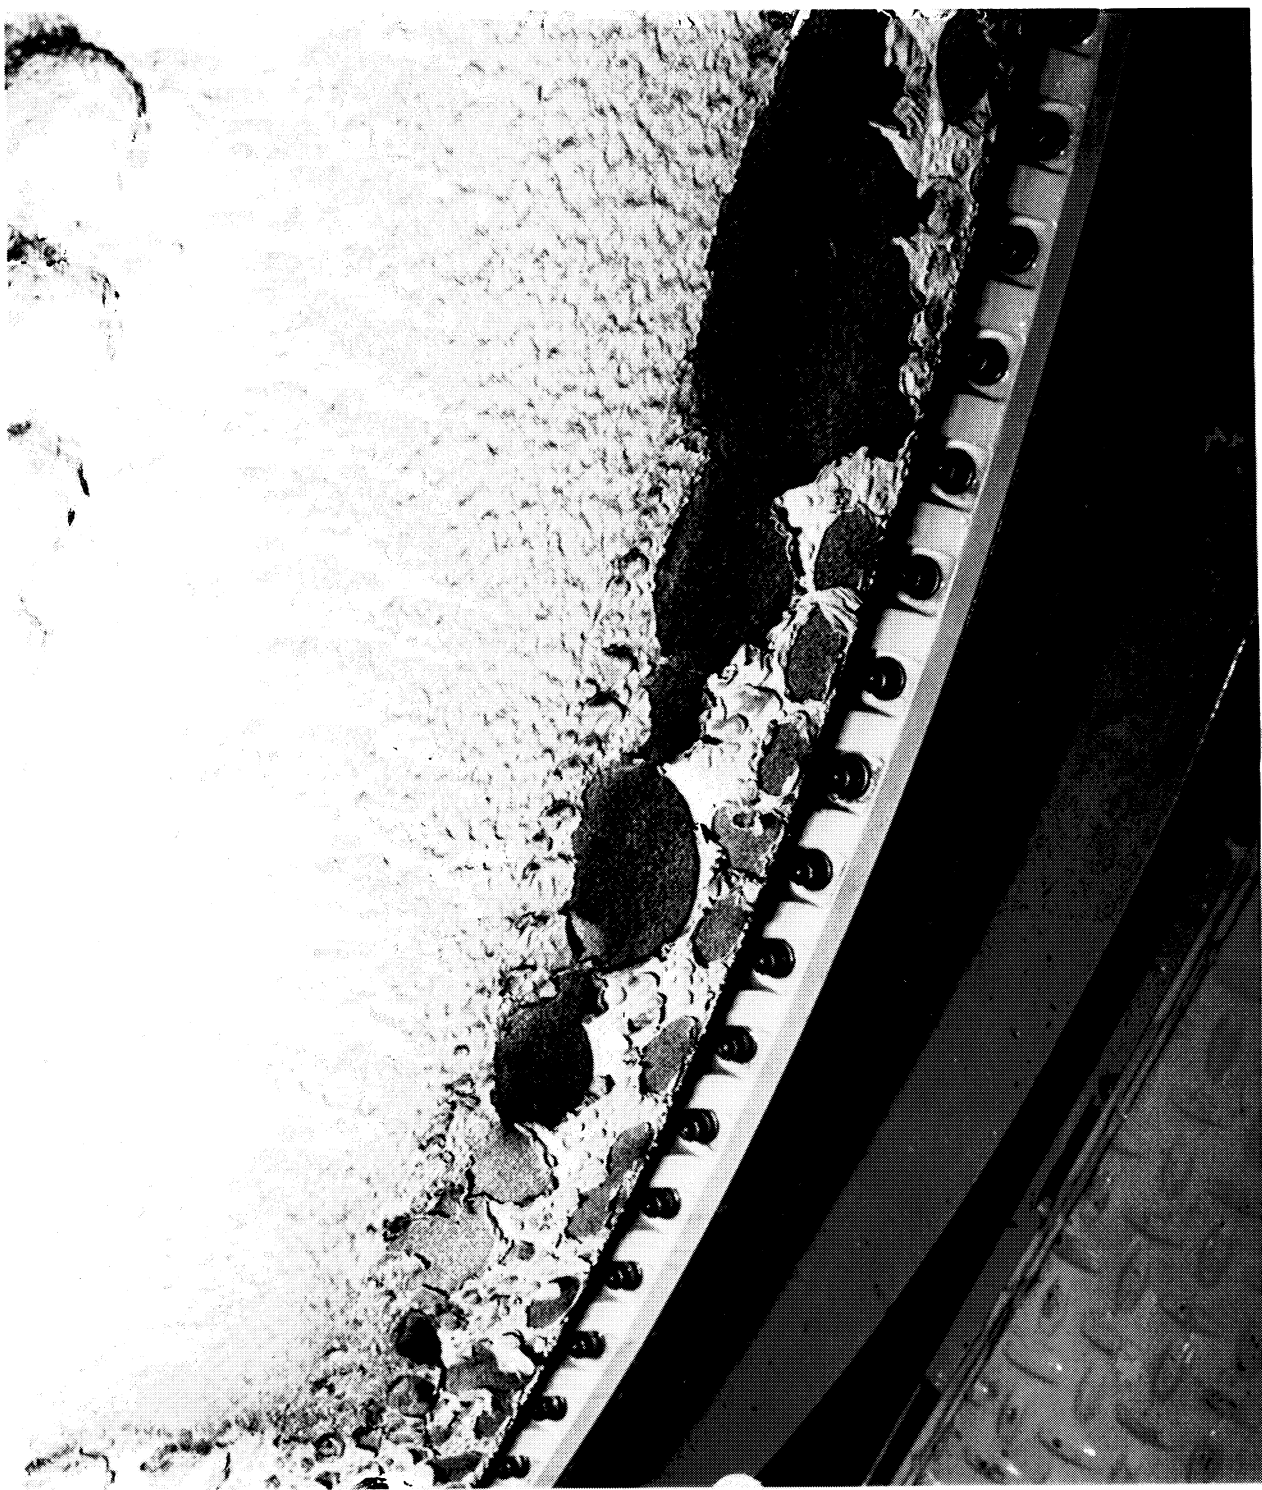
Photo 19 : Blistered/Missing Hypalon Paint

Hypalon paint was blistered/missing along the 395 ring frame where BTA had been applied. Some of the underlying BTA was lightly sooted.

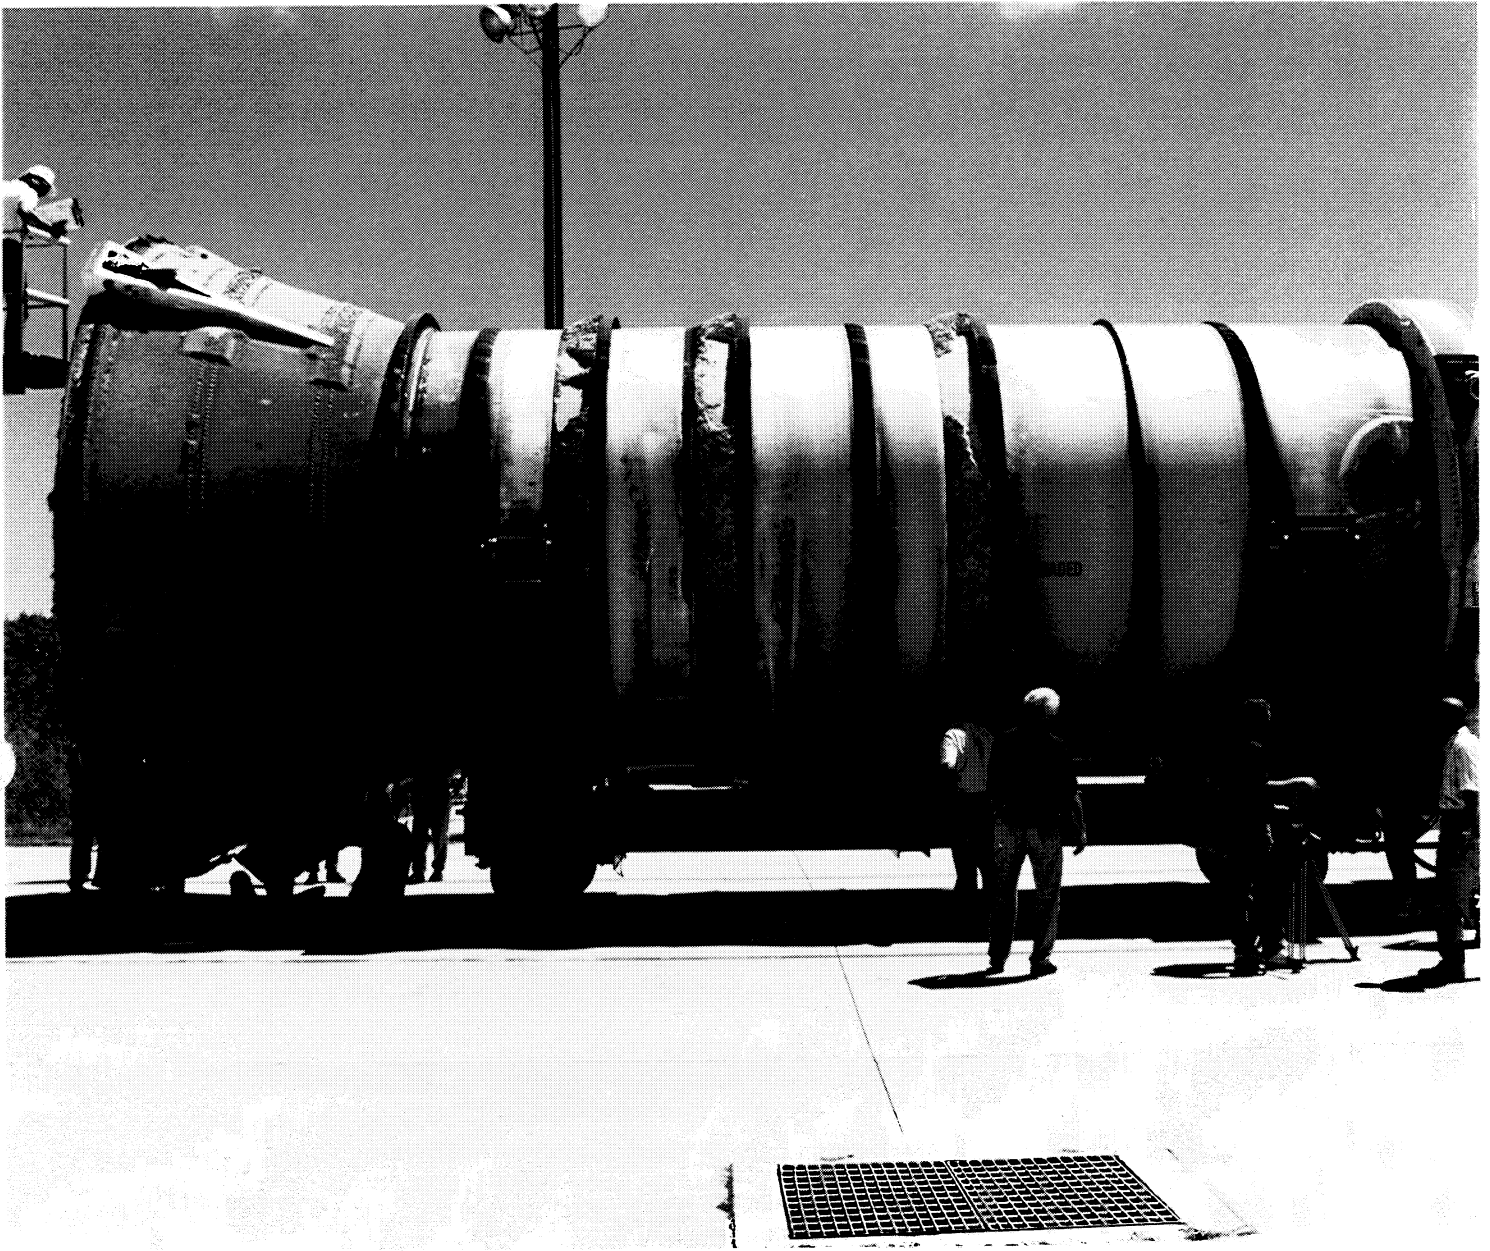
Photo 21 : RH Aft Booster / Aft Skirt

Separation of the aft ET/SRB struts appeared normal. The ET/SRB aft struts, ETA ring, IEA, and IEA covers appeared undamaged. SRB stiffener rings were damaged by water impact. The aft booster stiffener ring splice plate closeouts were intact and no K5NA material was missing.

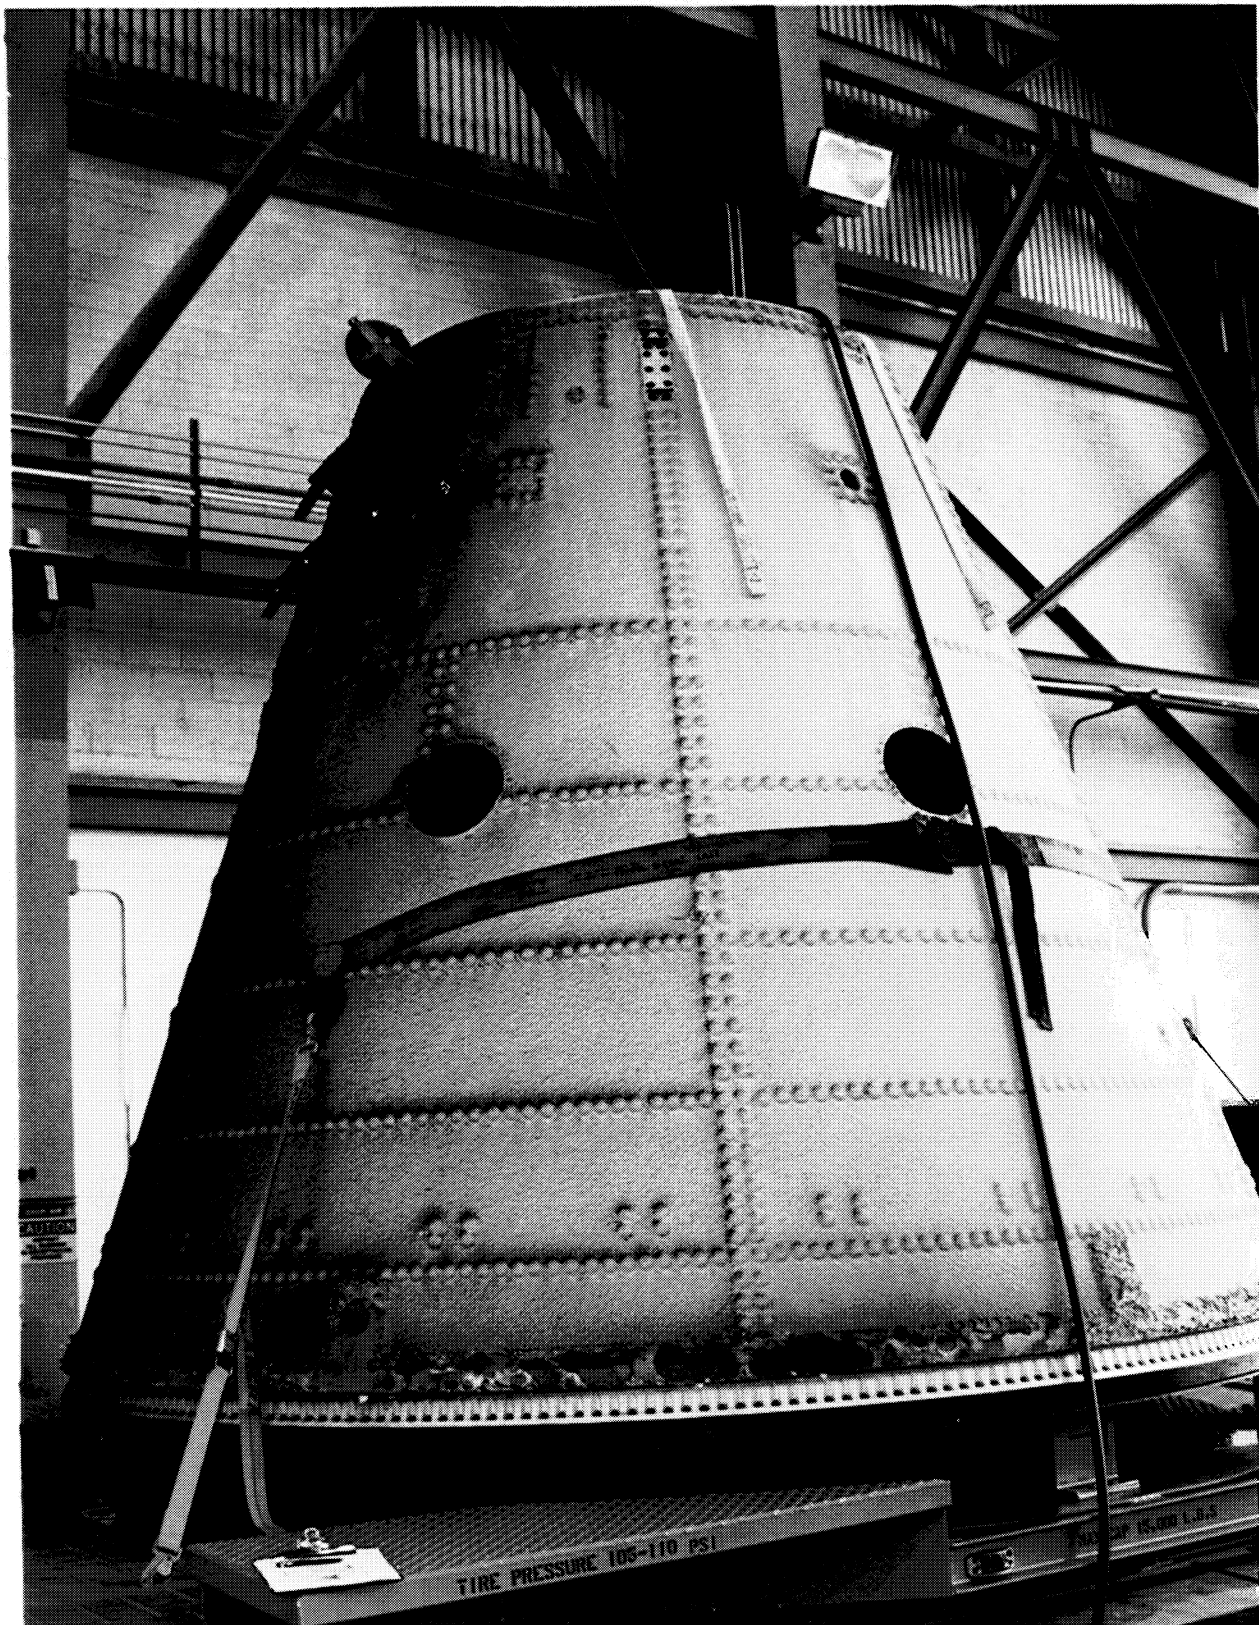
Photo 22 : LH SRB Frustum

The LH frustum was missing no TPS but had 11 MSA-2 debonds over fasteners.. All BSM aero heat shield covers had locked in the fully opened position. However, the upper right cover was bent backward to the 90 degree position and the attach ring had been deformed by parachute riser entanglement.

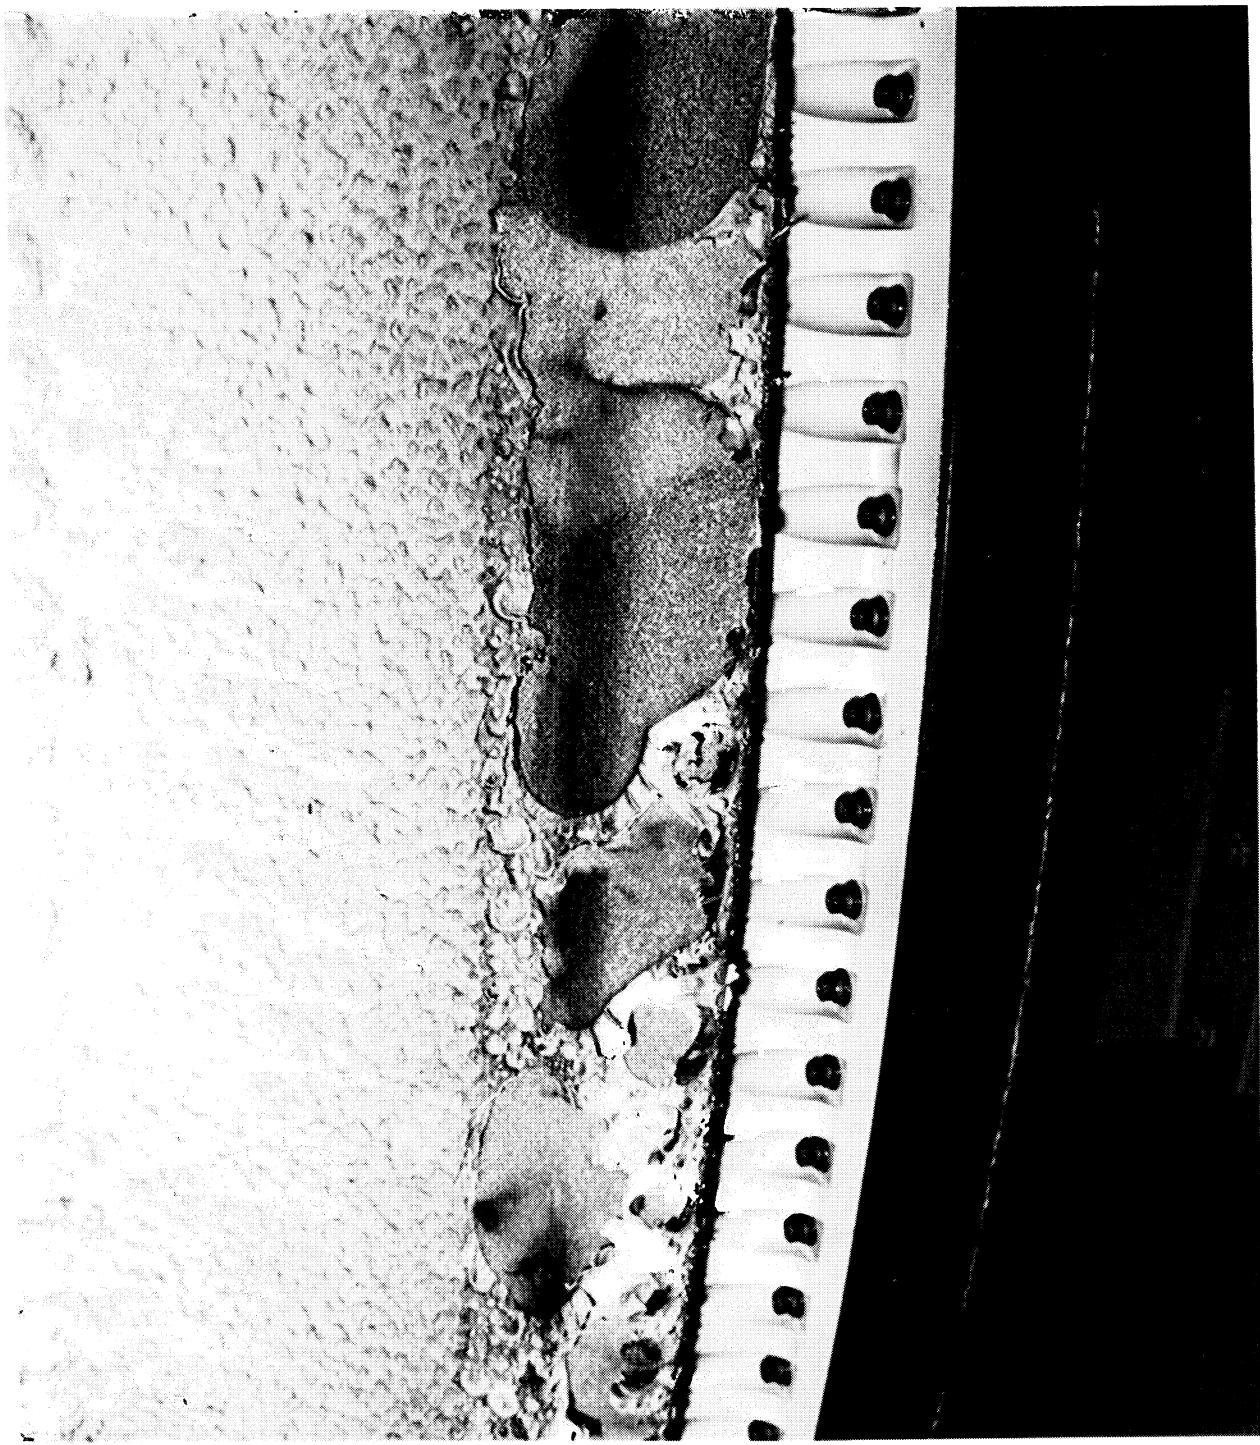
Photo 23 : Blistered/Missing Hypalon Paint

Hypalon paint was blistered/missing along the 395 ring frame where BTA had been applied

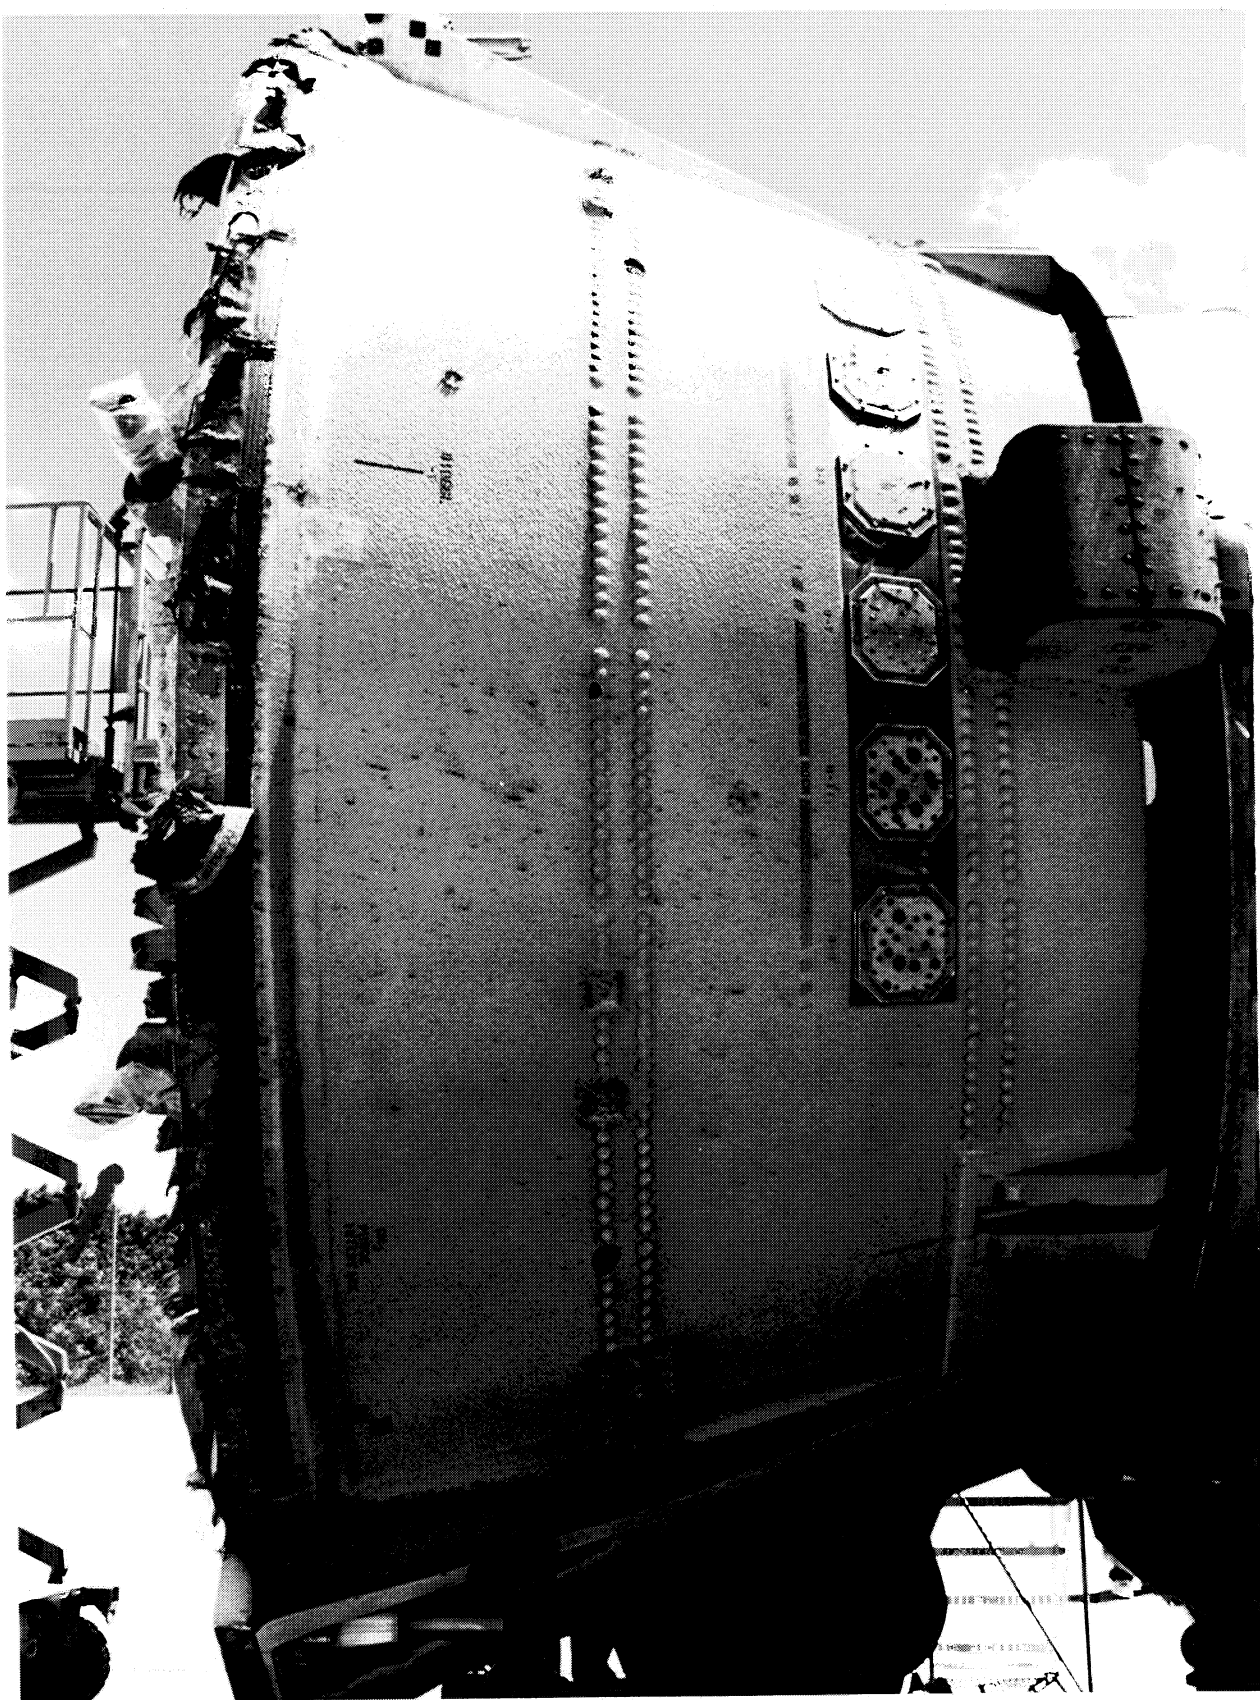
Photo 26 : Areas of missing TPS on LH aft skirt

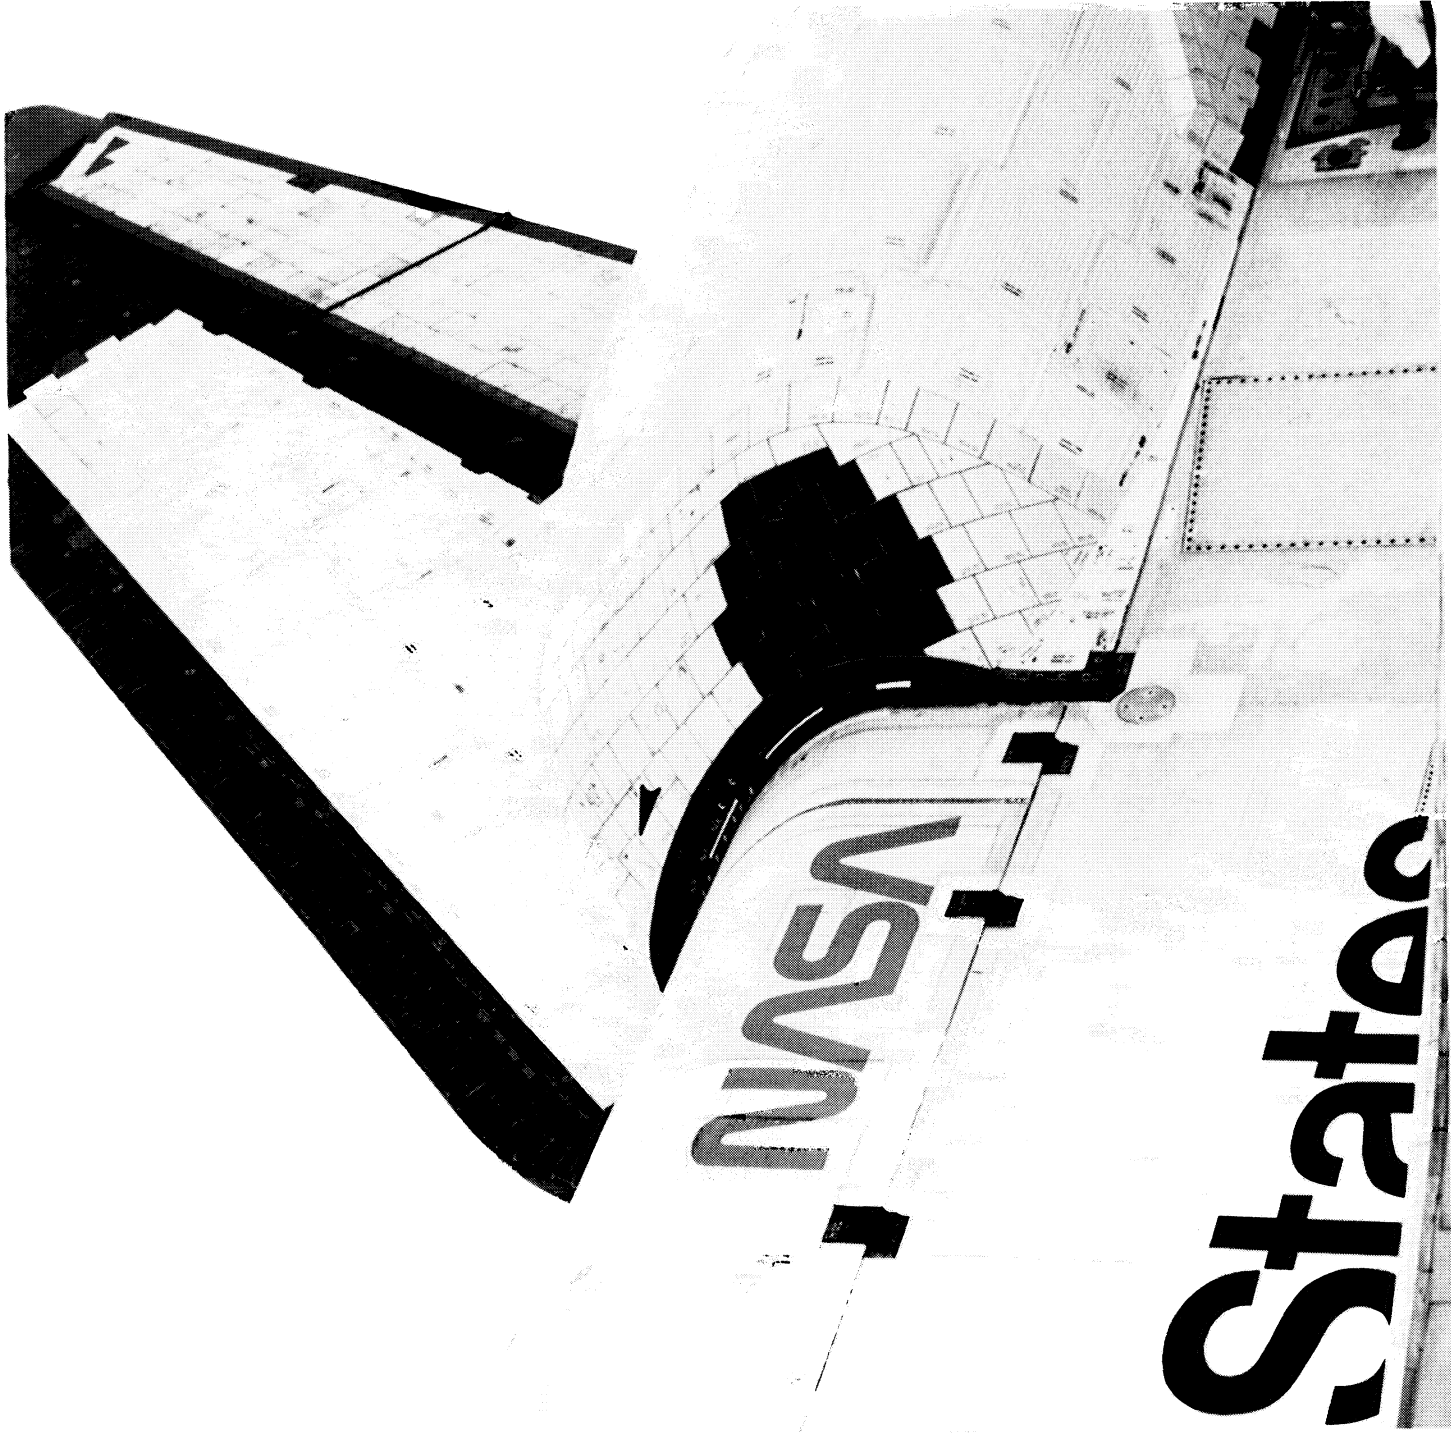
The largest tile damage site measured 6.5" x 2.9" x 1.9" (50 percent of the area to substrate) on the LH OMS pod leading edge tile V070-396450-007 and was most likely the result of an ice impact during reentry. Ice may have formed on the waste water dump nozzle due to an on-orbit problem with this system. On-orbit photos taken seven days into the mission confirmed the damage was not present at that time.

Photo 34 : Left OMS Pod tile damage.

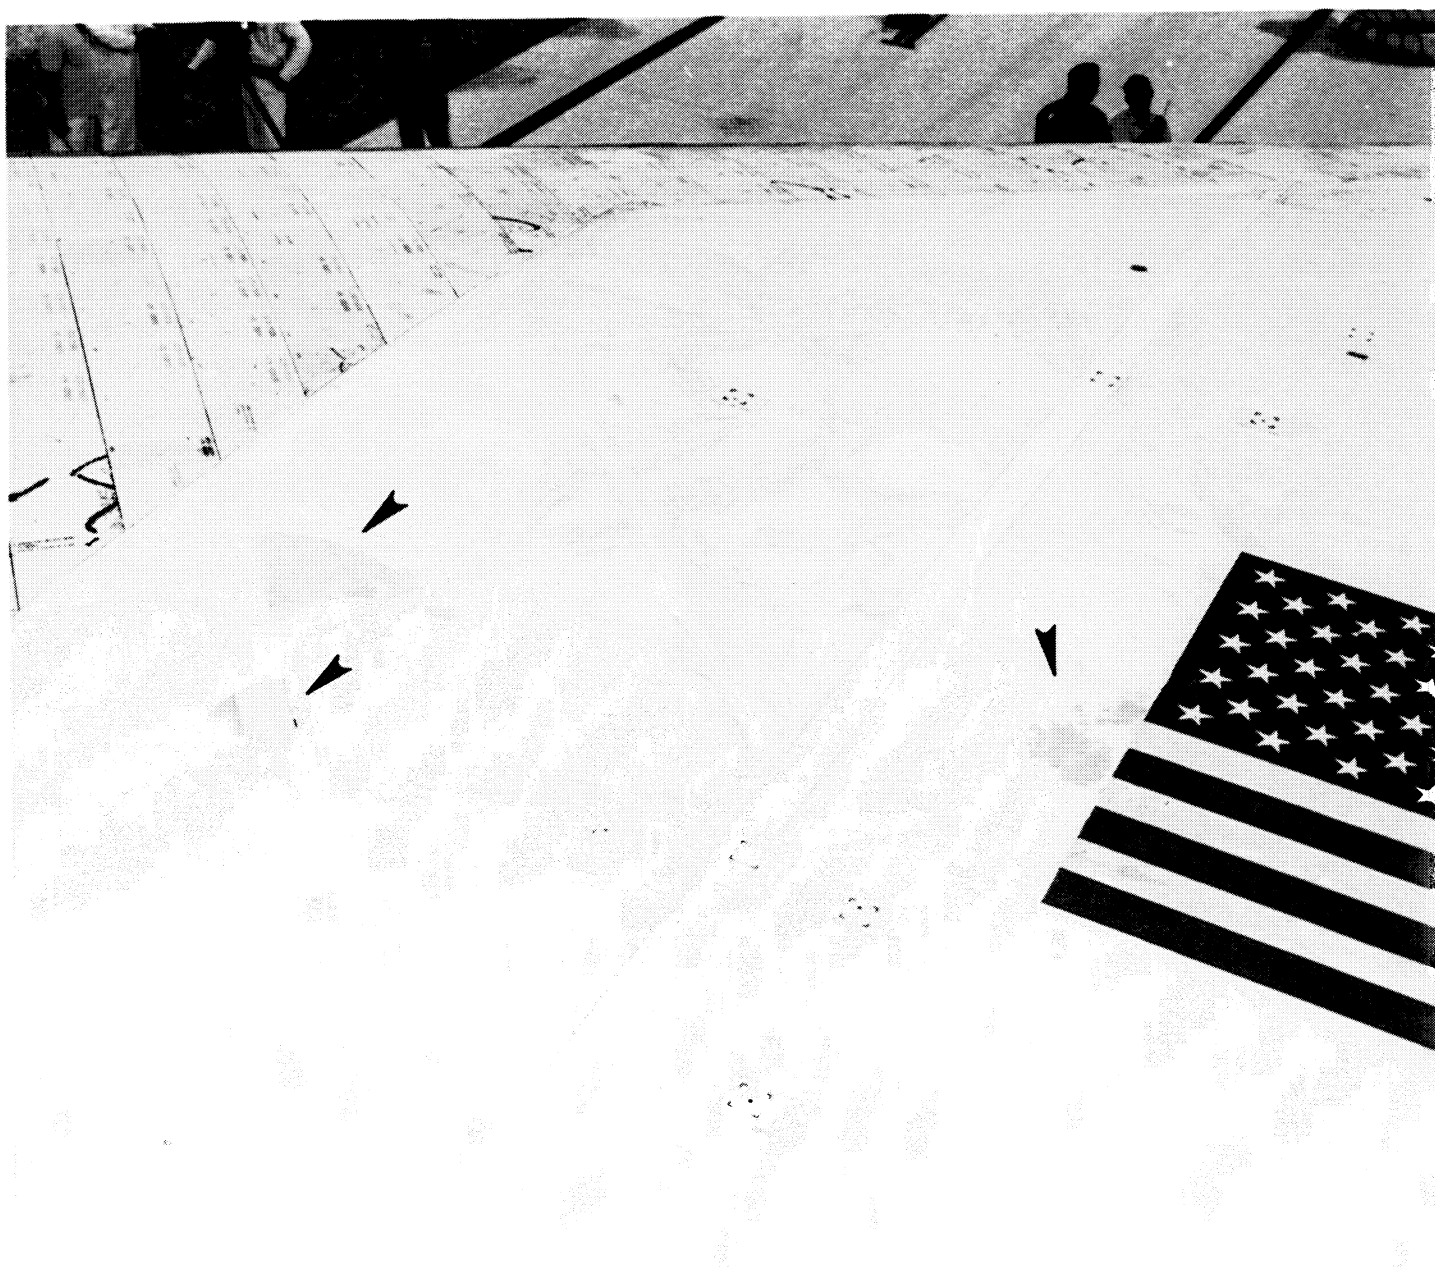
Photo 35 : Blanket topcoat missing from LH wing upper surface

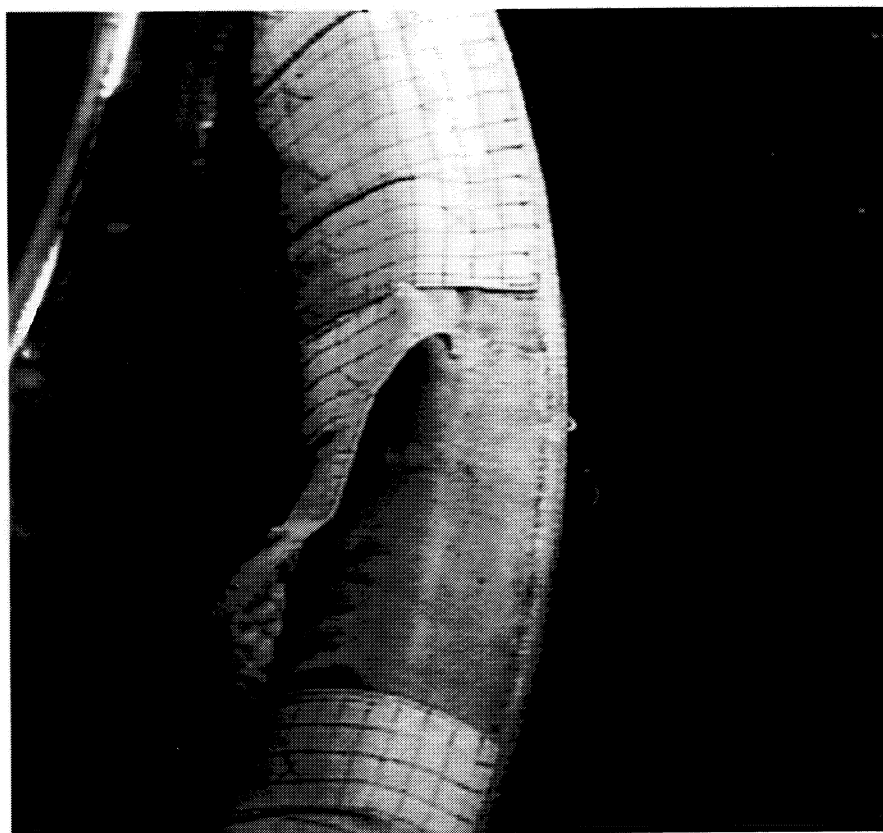
Figure 1.1.3 **Damage to the SSME #2 DMHS**

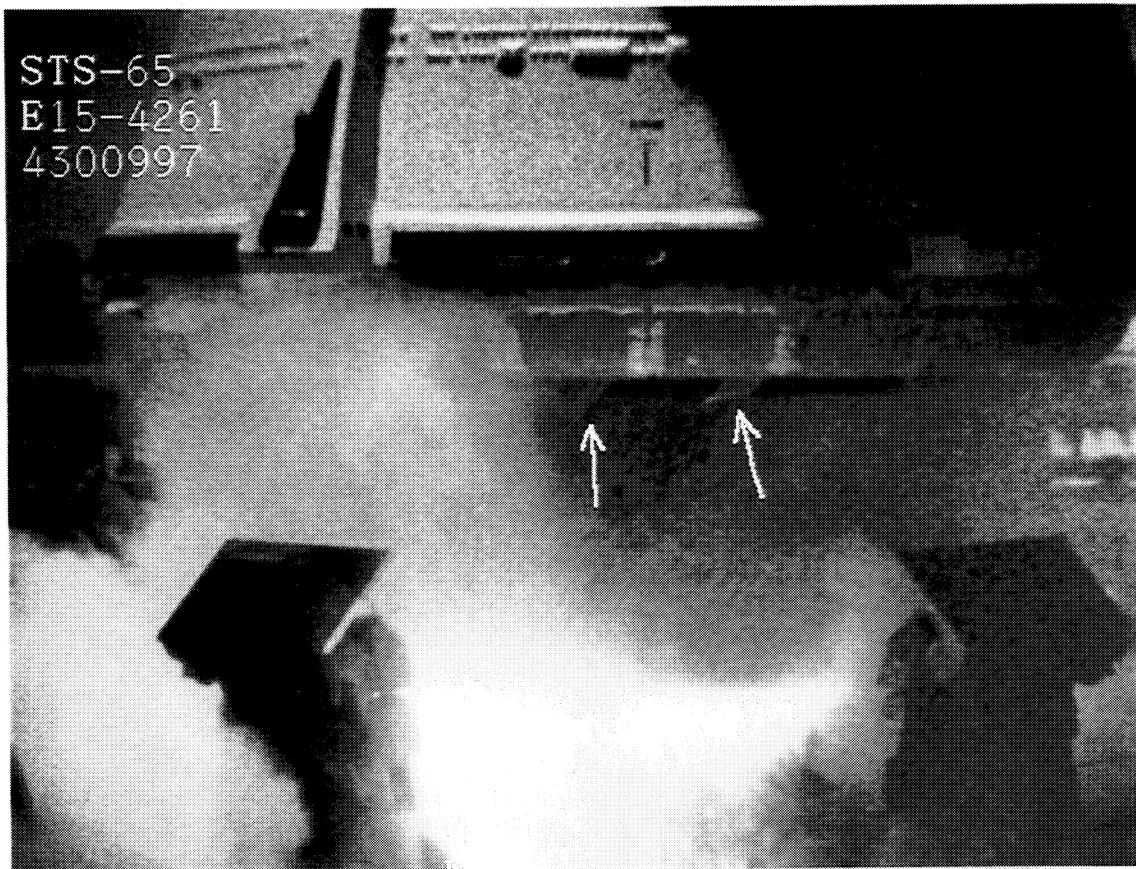
Figure 2.2.3 Two Loose Pieces of Thermal Curtain Tape on RSRB
(Camera E-15)

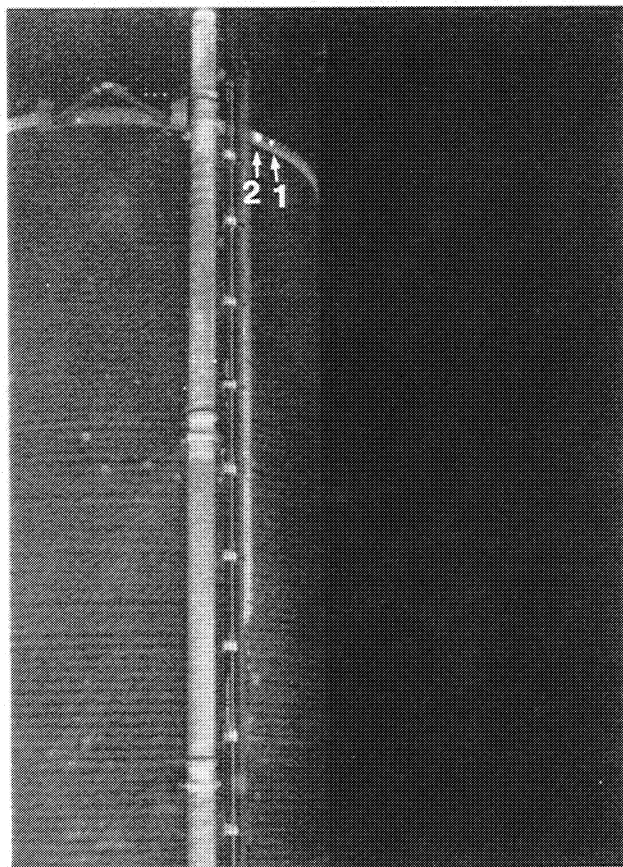
Figure 2.4.2.2a Divots on the LH2 Intertank Interface
(Frame S65-53-41)

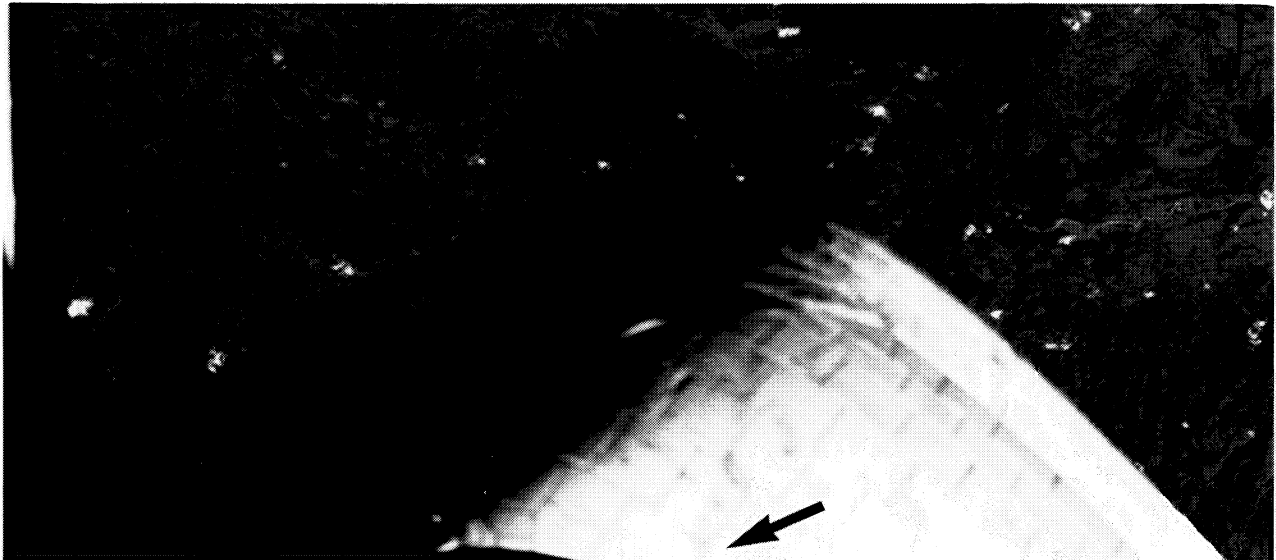
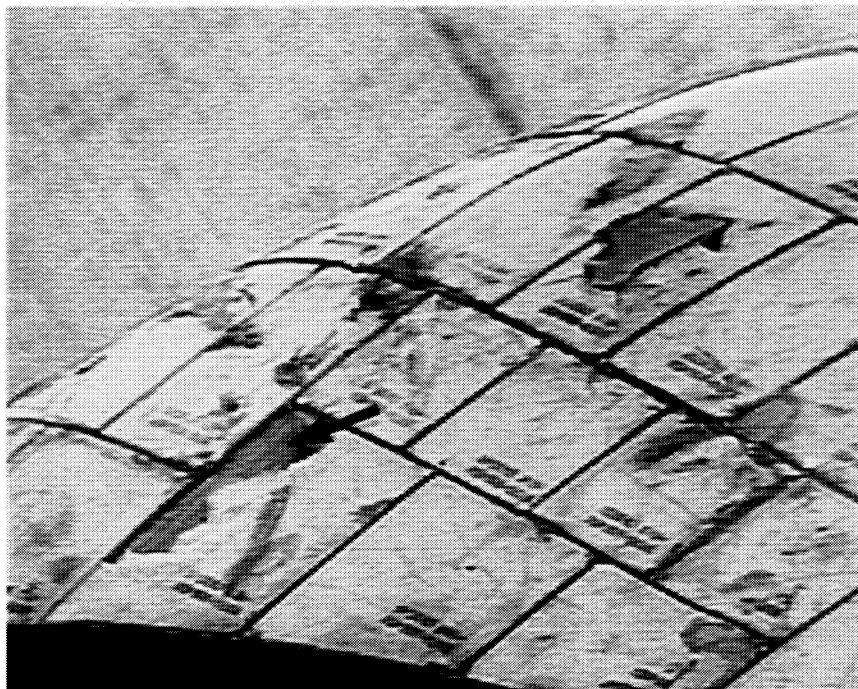
Figure 2.6.3 View of the Left OMS Pod Prior to De-orbit and During the Post Landing Inspection

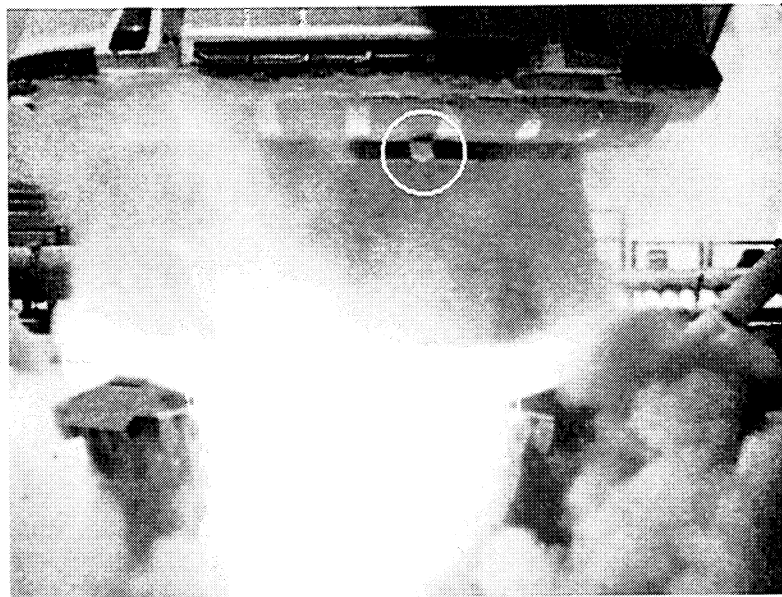
Loose thermal curtain tape was noted just after lift-off from camera E-15 as shown in Figure 4.

Figure 4 Loose Thermal Curtain Tape at Liftoff
